CITY OF CONCORD, NEW HAMPSHIRE FACILITY CONDITIONS ASSESSMENT

BEAVER MEADOW GOLF COURSE CLUB HOUSE

NOVEMBER 5, 2021

TTG PROJECT No. 4980

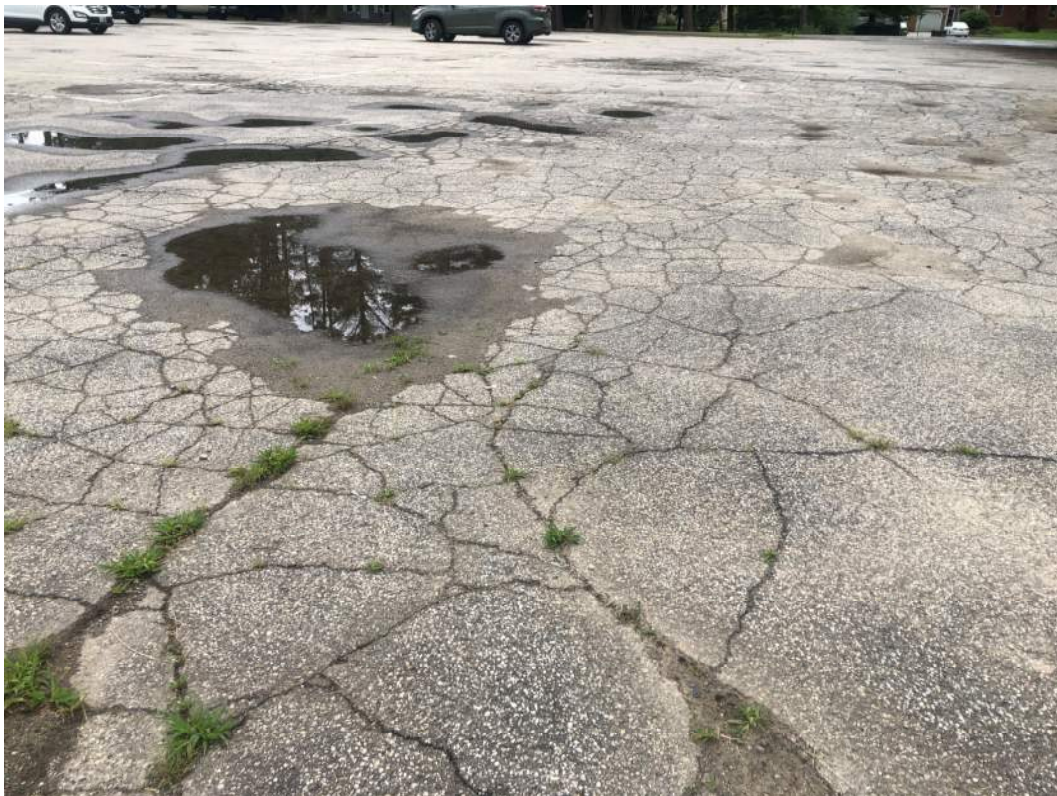
Badly Cracked and Deteriorated Pavement - Typical for All Areas of Parking Lot

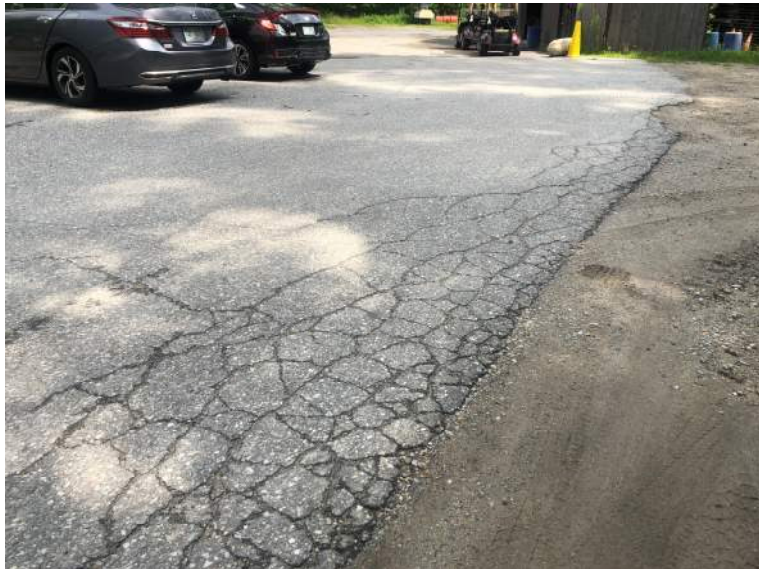
Typical Collapsed Edge of Bituminous Pavement Around Perimeter of Most Paved Areas

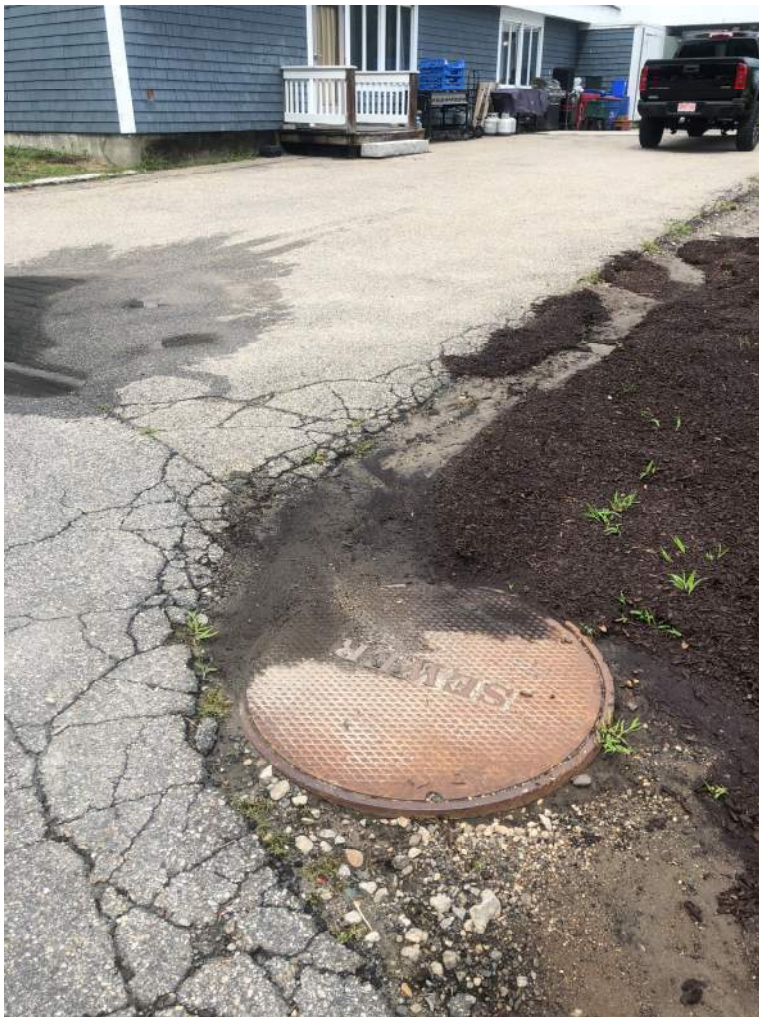
Collapsed Edge of Pavement Southwest of Club House towards Maintenance Building

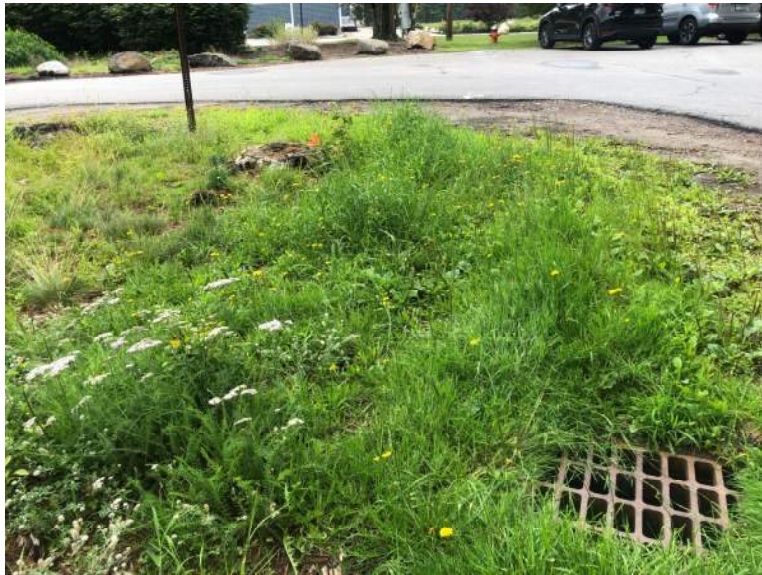
Only one (1) catch basin was observed in the proximity of the Club House and is located in a small grass area north west of the building. The sump in the catch basin should be cleaned of internal silt.

Catch Basin Located Southwest of Club House

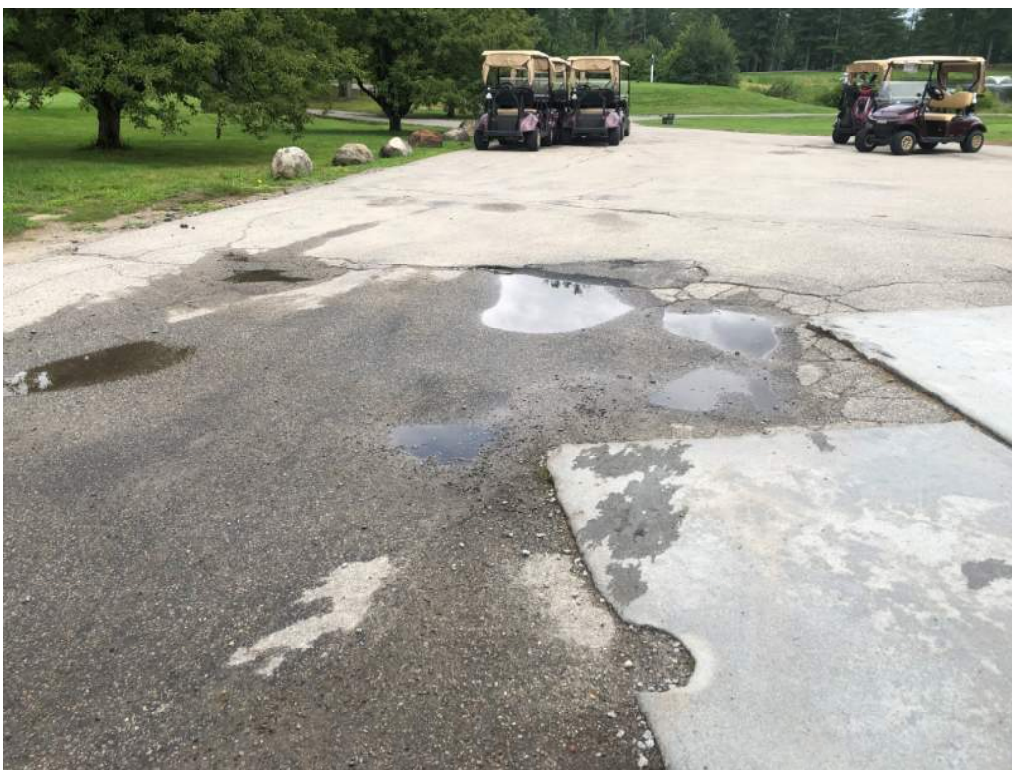
Ponding, Cracked Pavement, Collapsed Edges, Broken Hardscaping, Tripping Hazard – Northeast of Club House

The hardscaped areas at the east and south sides of the Club House should be regraded, re-set and or re-sloped to accommodate positive drainage and to eliminate any projections causing potential tripping hazards.

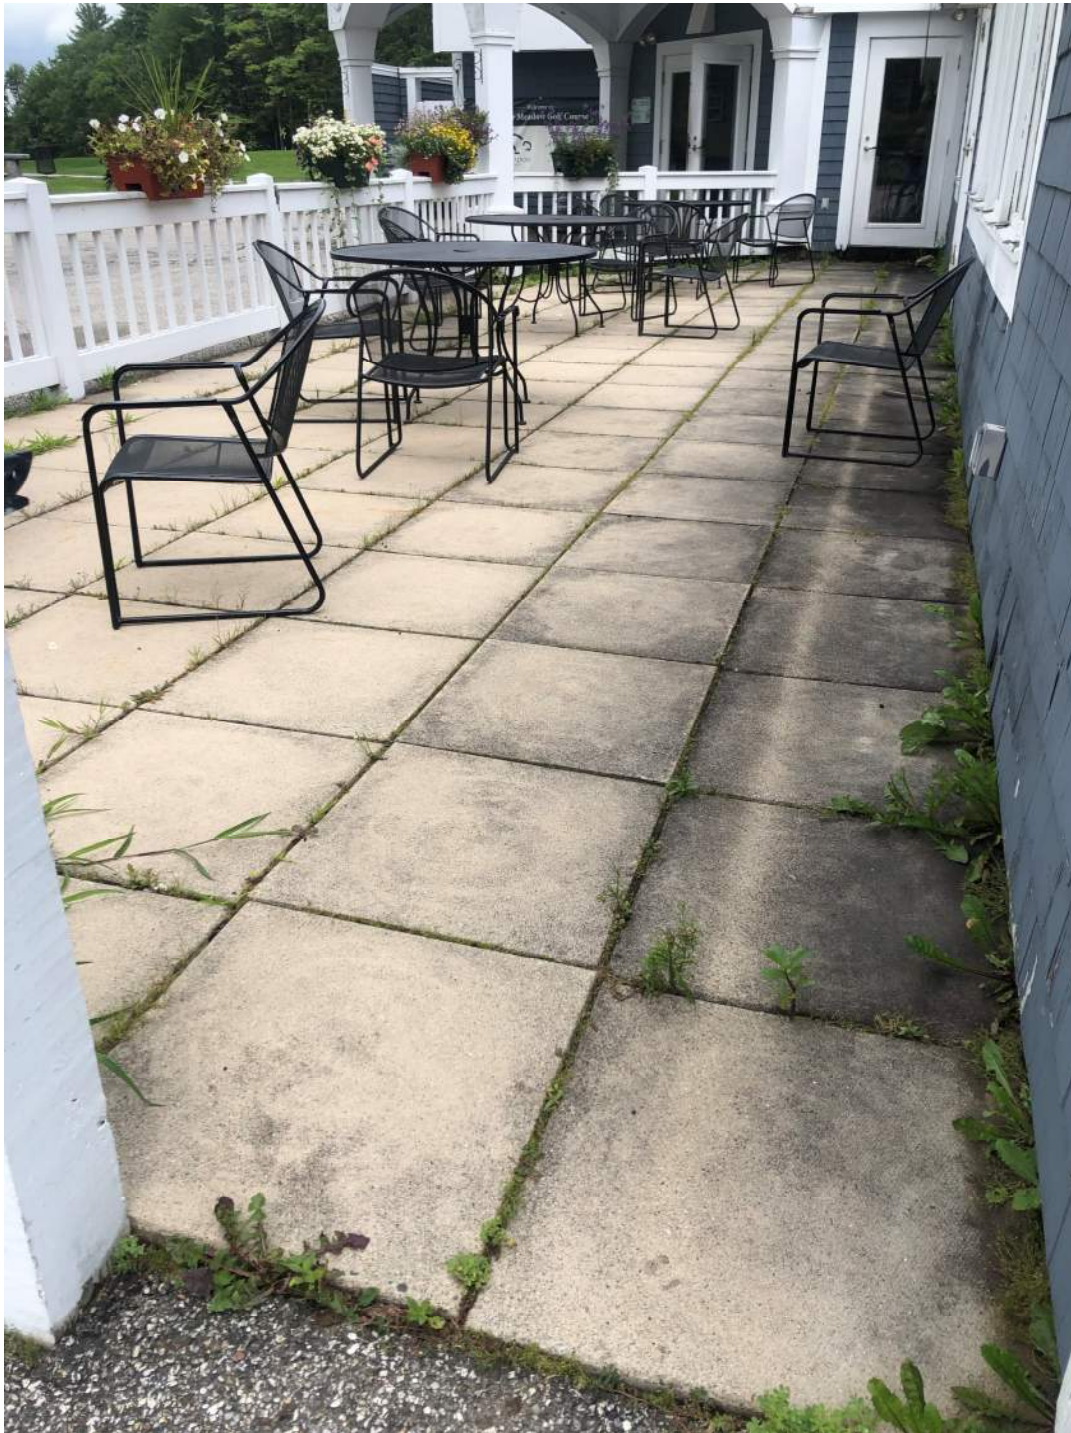
Hardscaping Southeast of Club House – Possible Tripping Hazard Entry at Bituminous Pavement

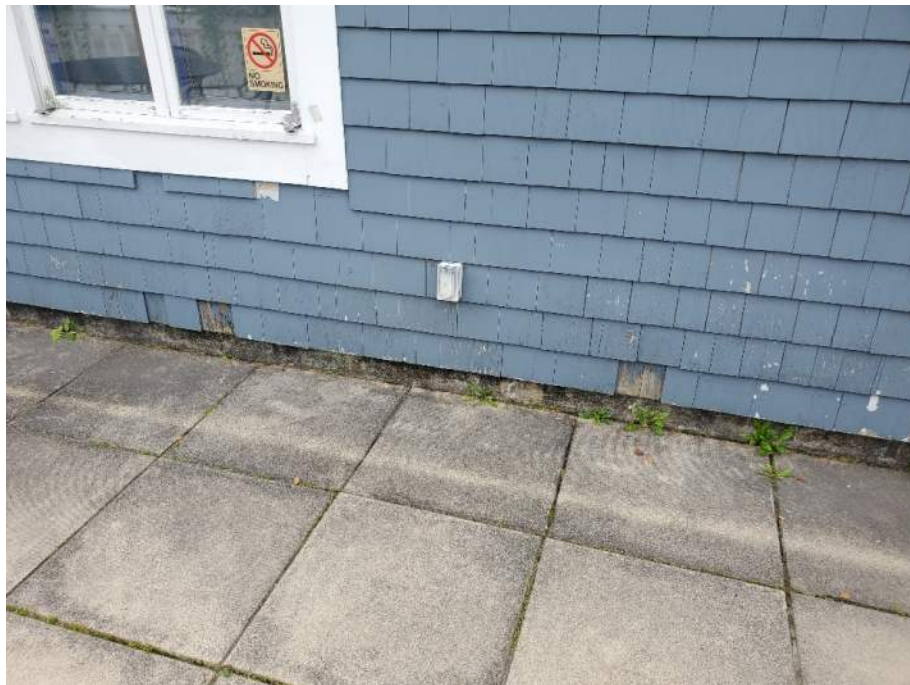
The exterior cedar wall shingles were noted to be in fair condition. There are a number of areas where the shingles have been damaged and are missing. Some of the shingles where the roof water hits pavement and splashes back are rotted and should be replaced.

Damaged Siding on North Side

Due to the condition of the exterior siding throughout the building, and considering the number of maintenance issues with painted or solid-stained wood siding, the recommendation is to replace the siding in its' entirety with a vinyl product that does not require painting and will not rot or deteriorate.

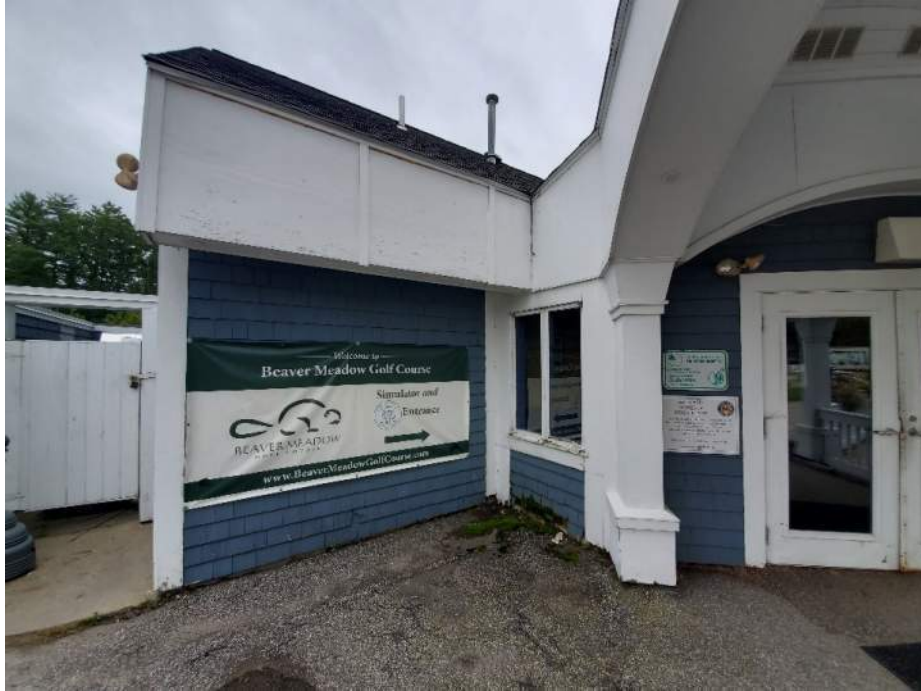
Damaged Siding on North Side

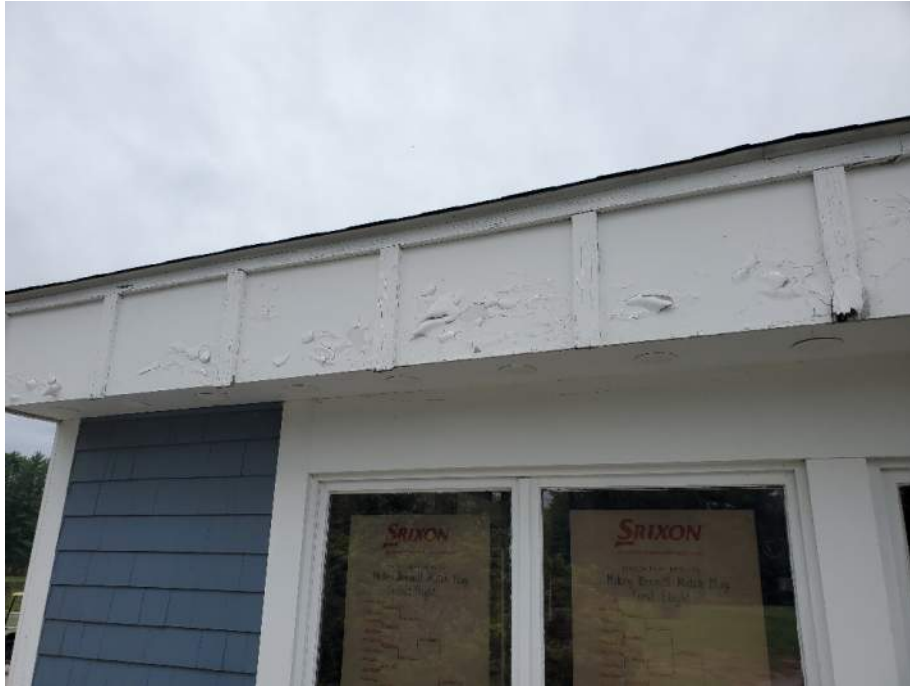
The painted finish on the projected wood roof fascia around the perimeter of the building are badly worn in need of refinishing.

Roof Fascia on North Side

Due to the condition of the exterior trim throughout the building, and considering the number of maintenance issues with painted wood trim, the recommendation is to replace the painted wood trim in its' entirety with a PVC trim that does not require painting and will not rot or deteriorate.

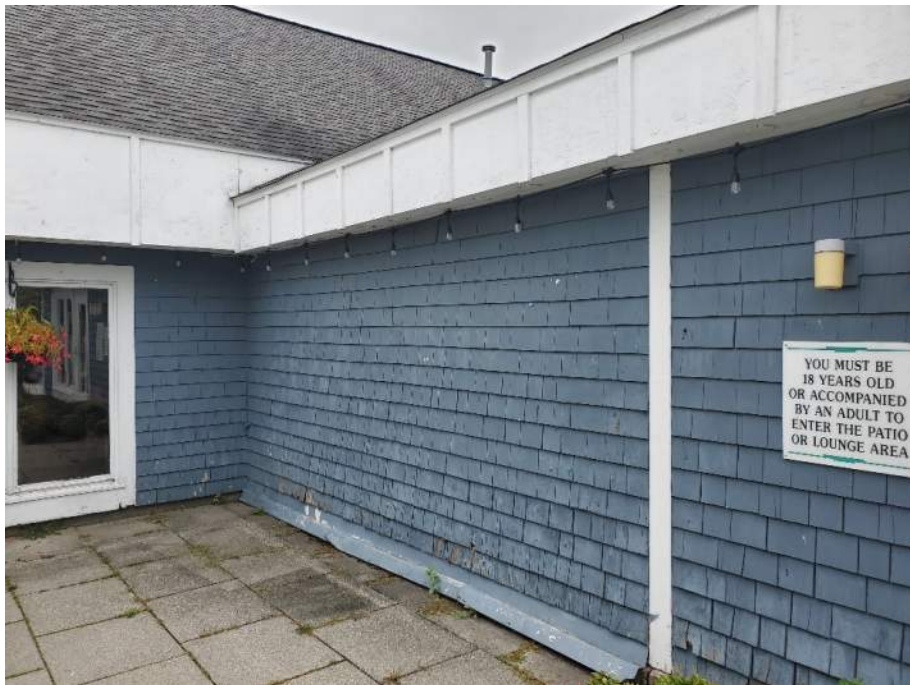
Damaged Siding & Roof Fascia

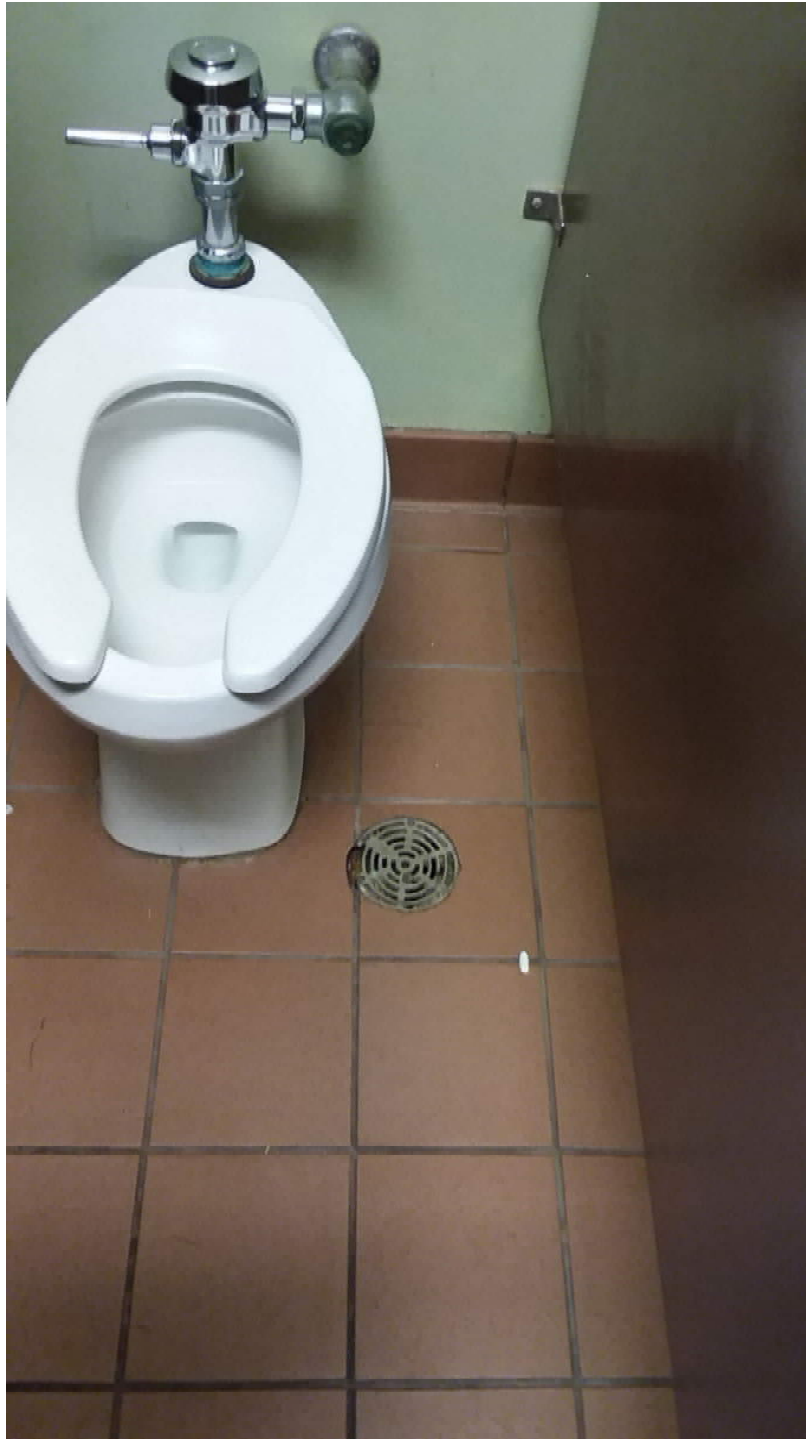
The tile flooring at the floor drain in the Men's restroom is chipped or broken.

Tile Flooring and Floor Drain in Men's Restroom

Replace the tile flooring at the floor drain in the Men's Restroom.

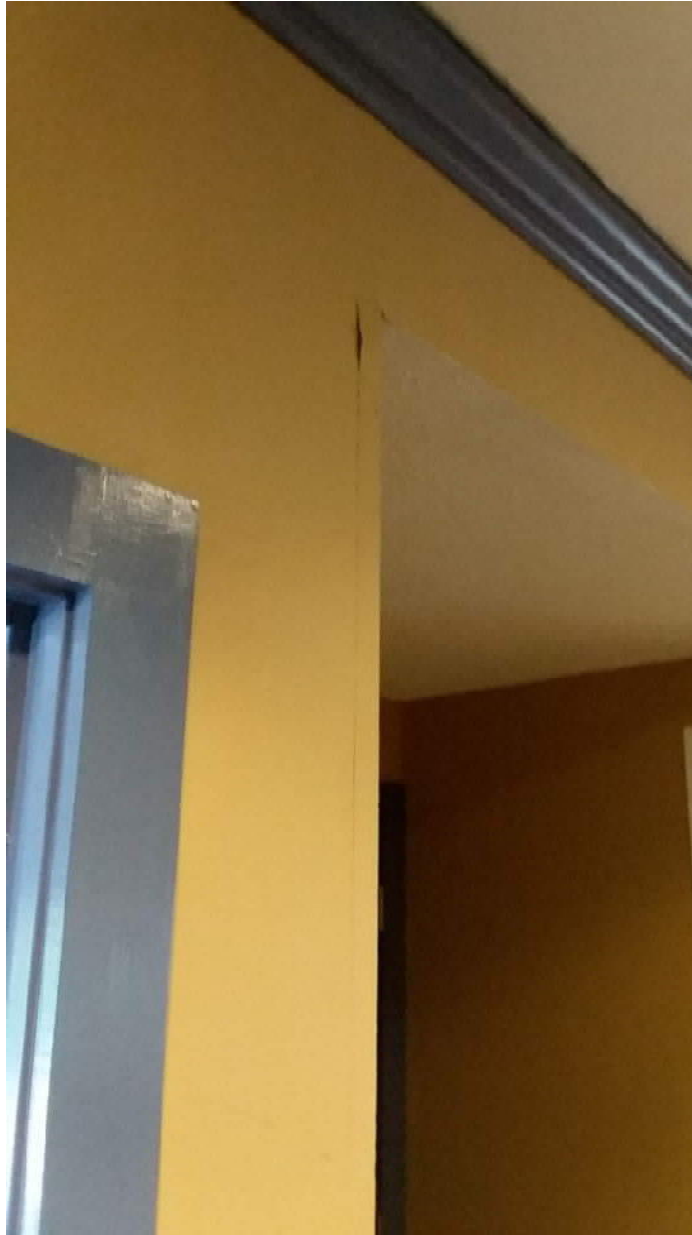
Wall Finish at Corner in Entry Hallway

Repair the corner of the interior wall finish surface that is separating in the entry hallway.

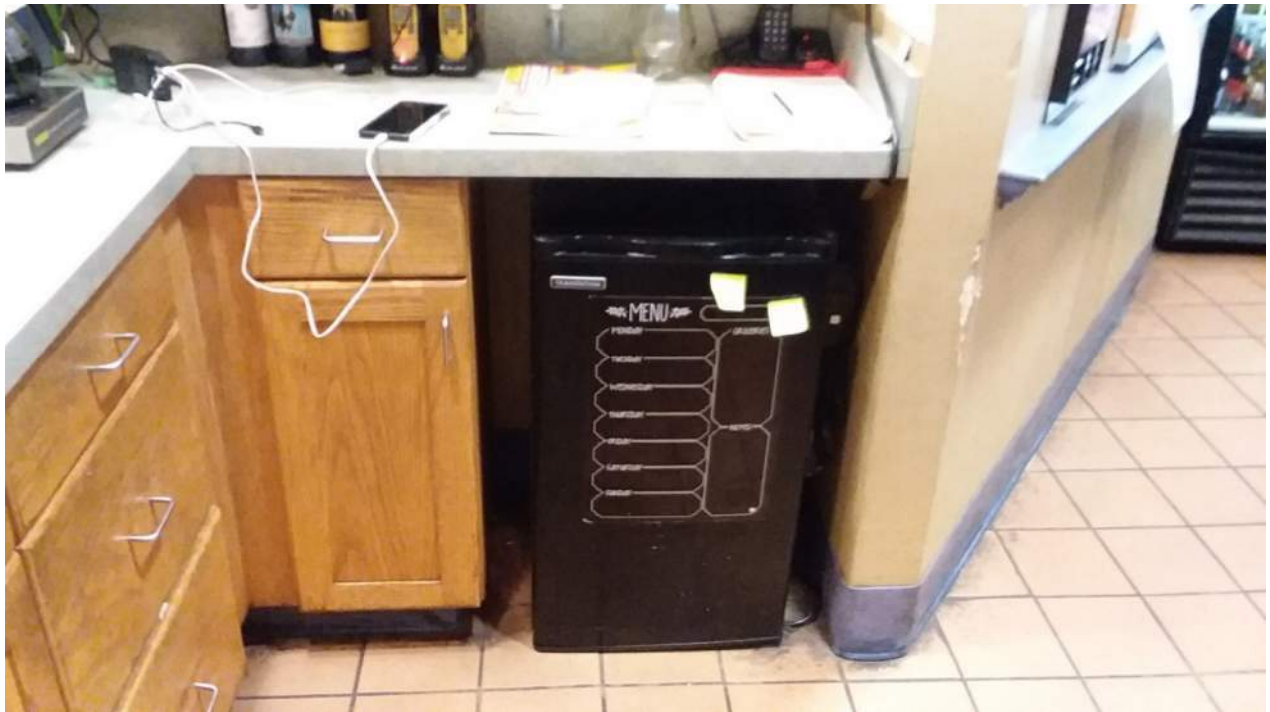
Wall Finish Behind Public Bar

Repair the chipped corner of the interior wall finish surface behind the public bar.

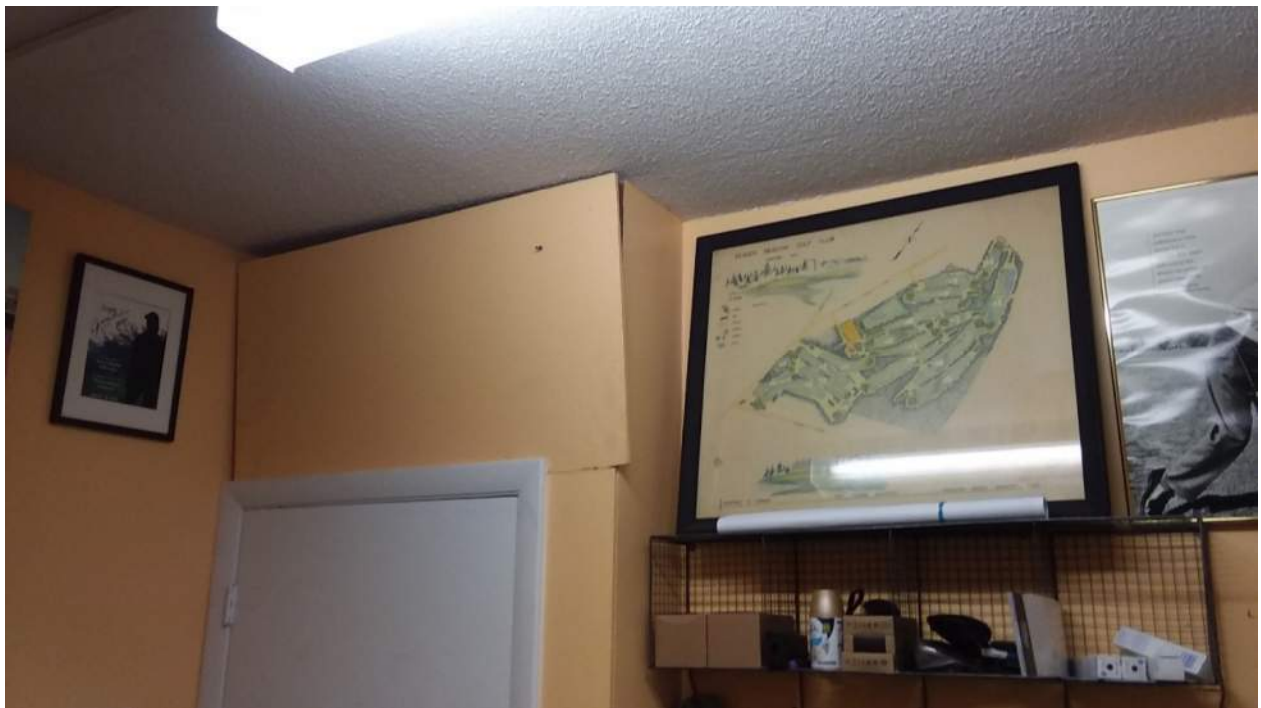
Wall Finish in Private Office

Repair or replace the detached wall surface above the closet door in the private office.

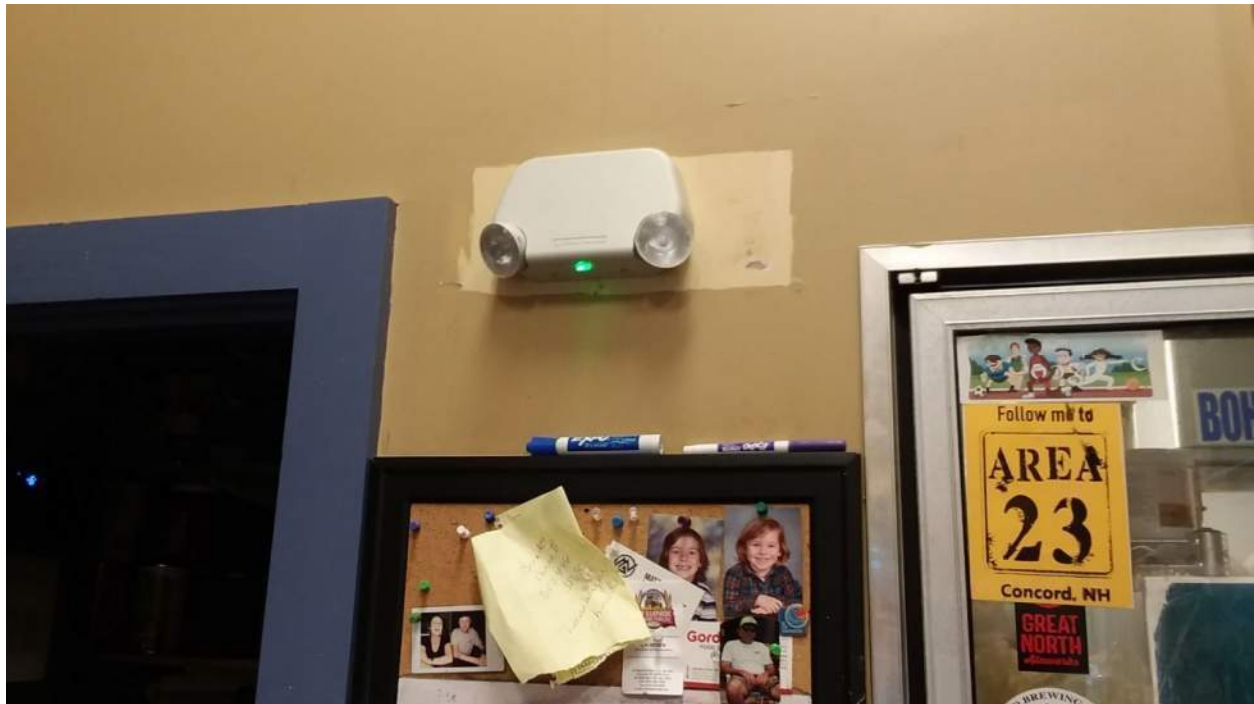
The interior wall finish surfaces in the kitchen, behind where larger emergency light fixtures were installed before being replaced with new smaller fixtures, is unfinished.

Wall Finish in Kitchen

Refinish the interior wall finish surfaces in the kitchen behind where larger emergency light fixtures were installed before being replaced with new smaller fixtures.

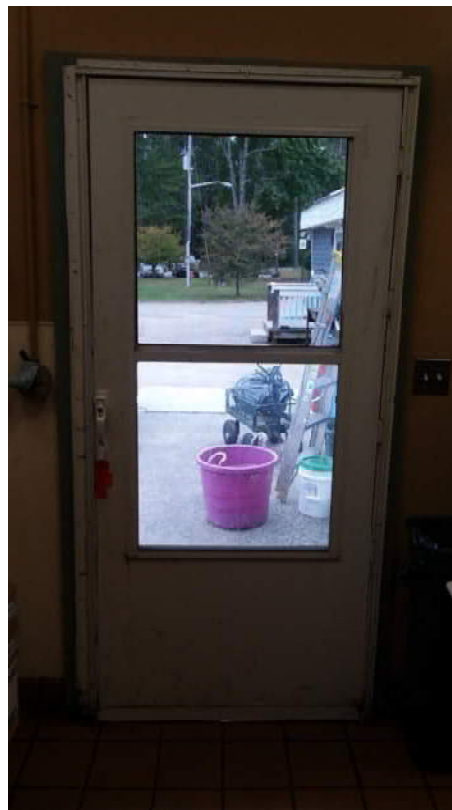
Exterior Door Condition in Kitchen

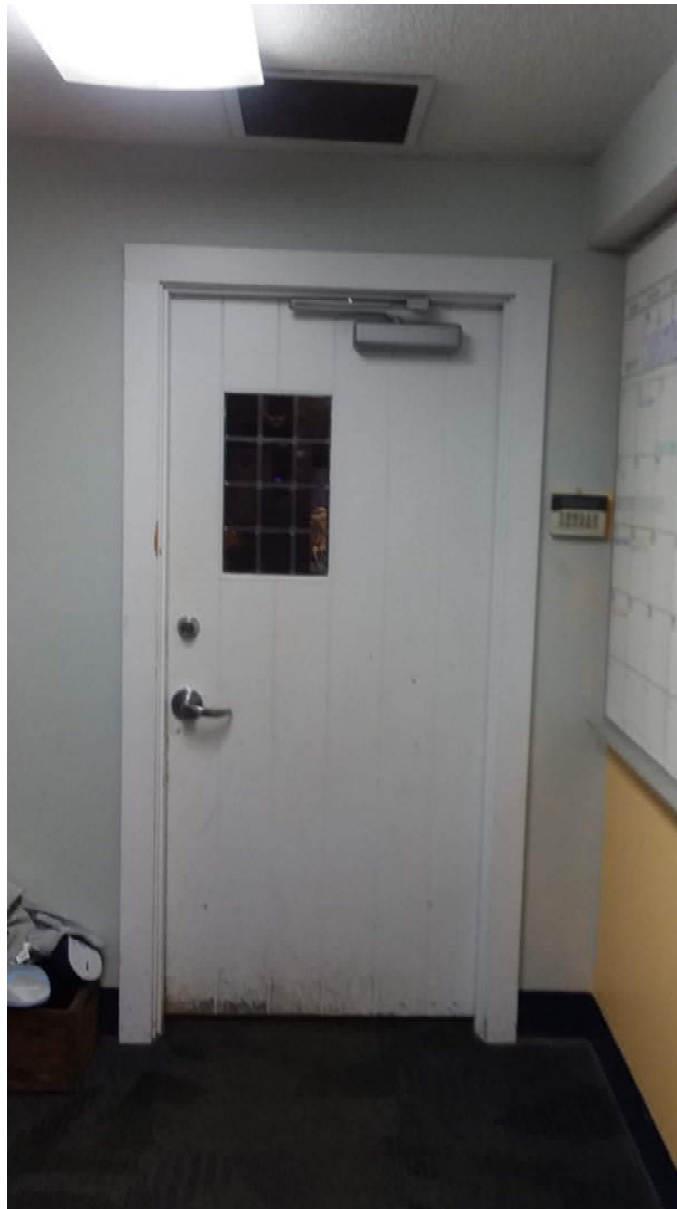
Interior Door Condition

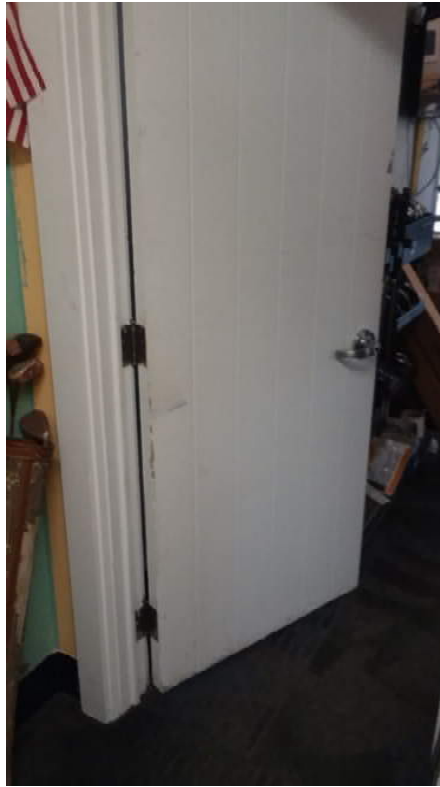
Interior Door Condition

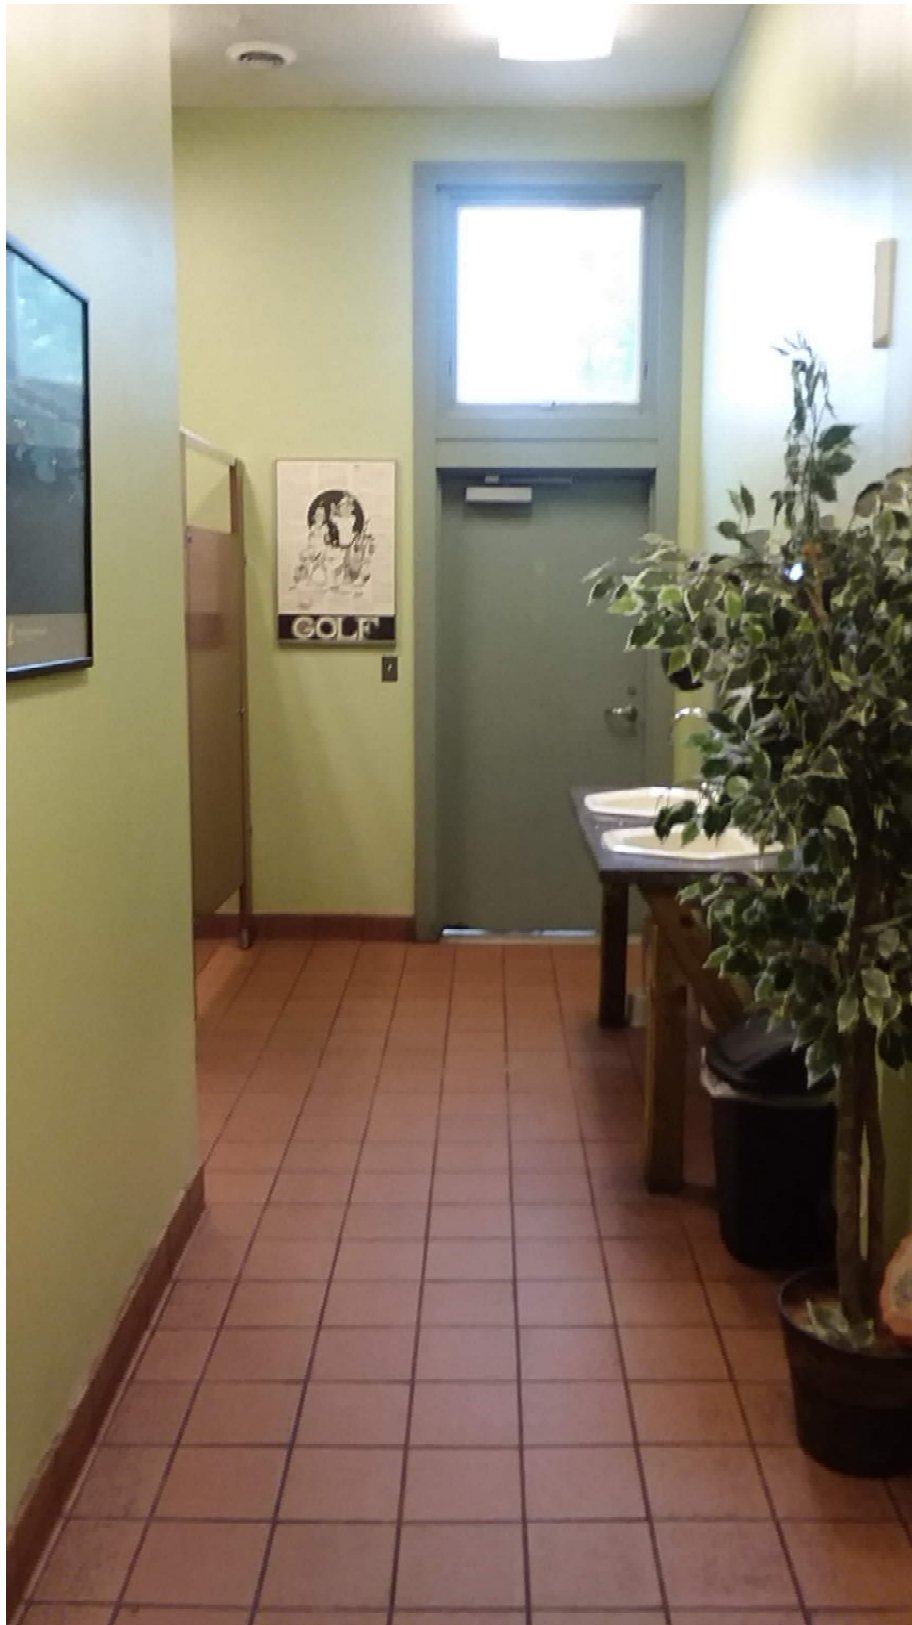
Exterior Door Threshold in Women's Restroom

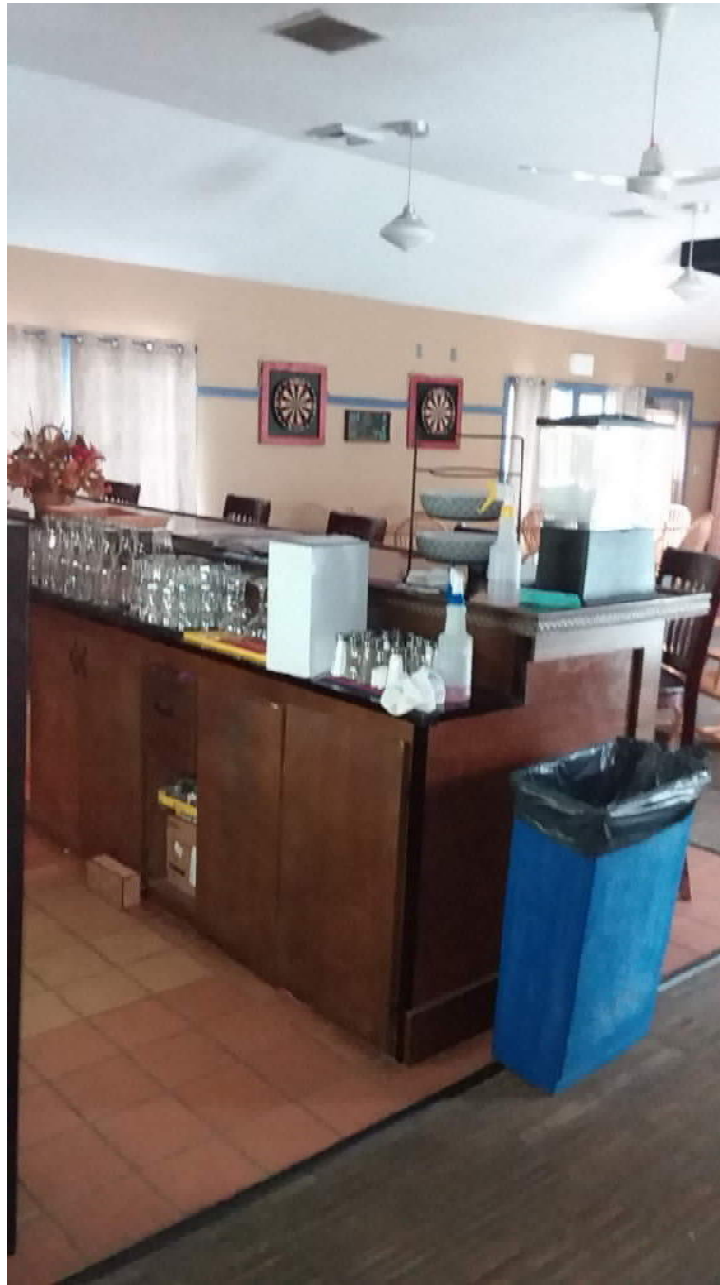
The condition of the finishes on the casework behind the clubhouse bar are worn and soiled.

Condition of Finishes on Casework Behind Clubhouse Bar

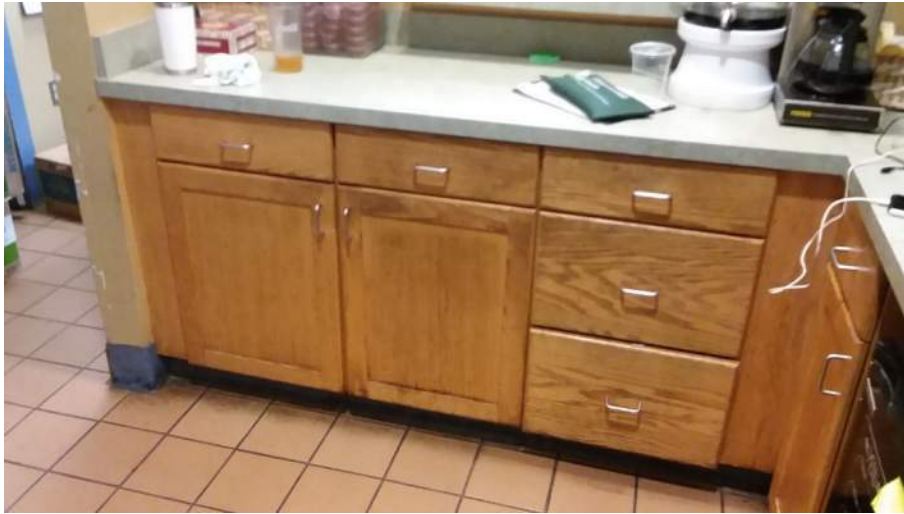
The condition of the finishes on the casework behind the public bar are worn and soiled.

Condition of Finishes on Casework Behind Public Bar

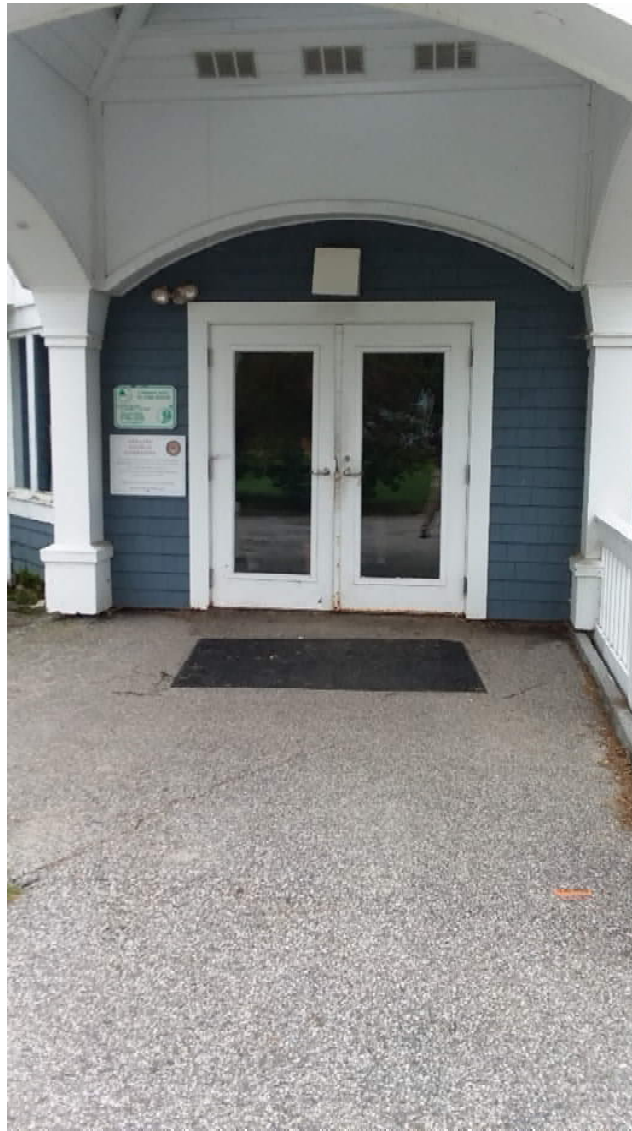
Accessible Entrance Sign Required

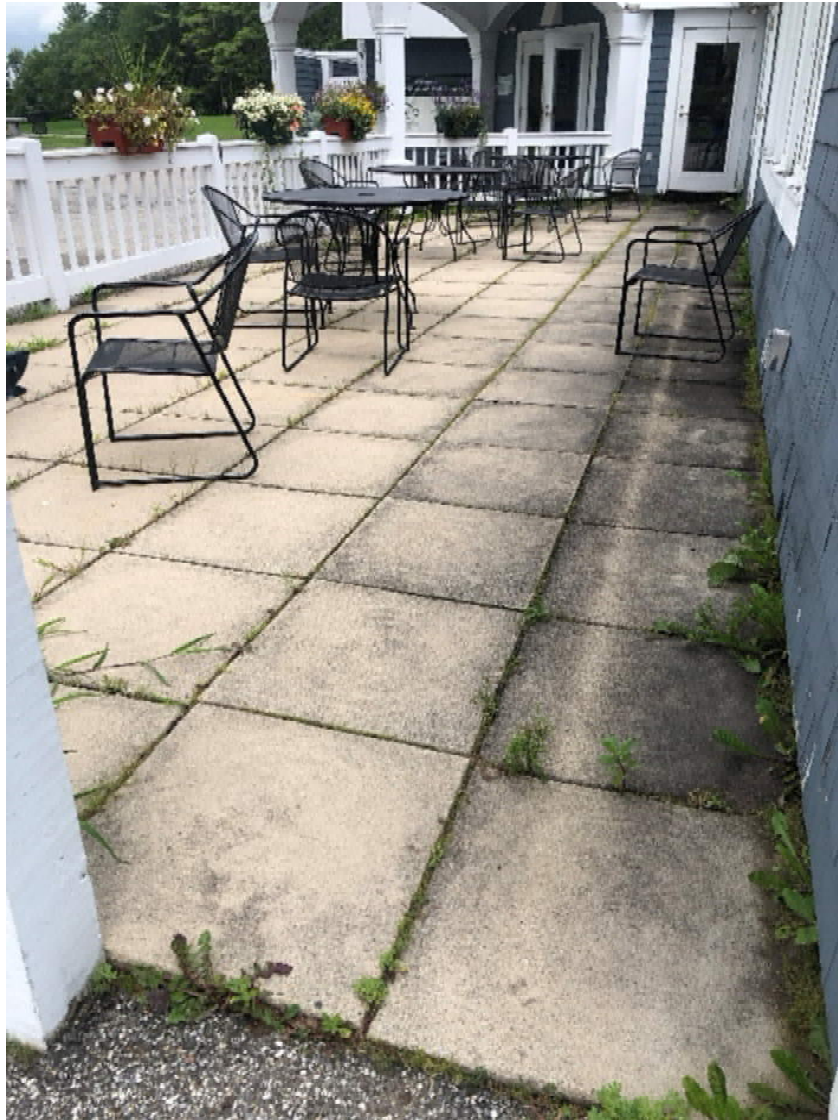
Patio Inaccessible from Interior of Building
Interior of Building Inaccessible from Patio

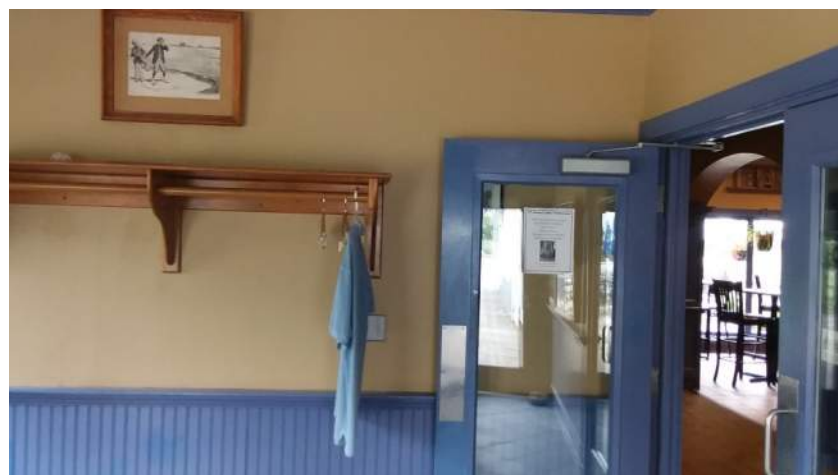
Non-compliant Headroom Clearance in Accessible Path of Travel

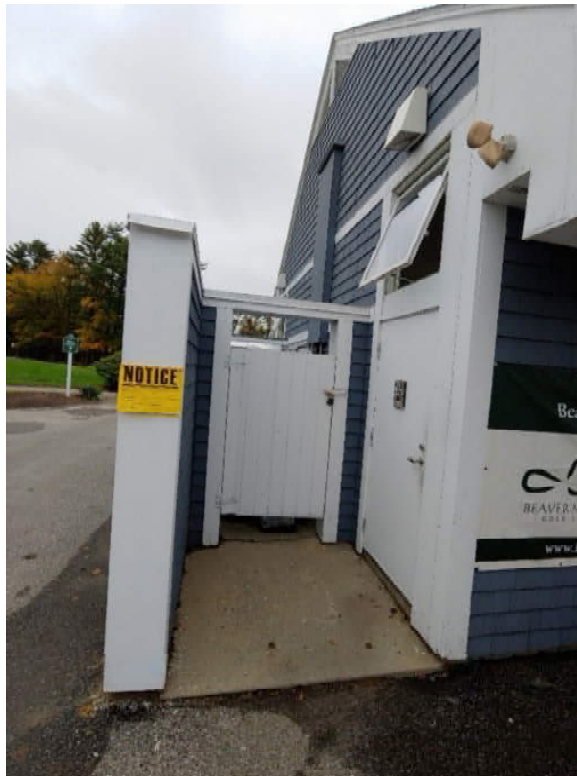
Public Restrooms Inaccessible from Exterior

Provide an accessible means of entry to the restrooms from the exterior of the building.

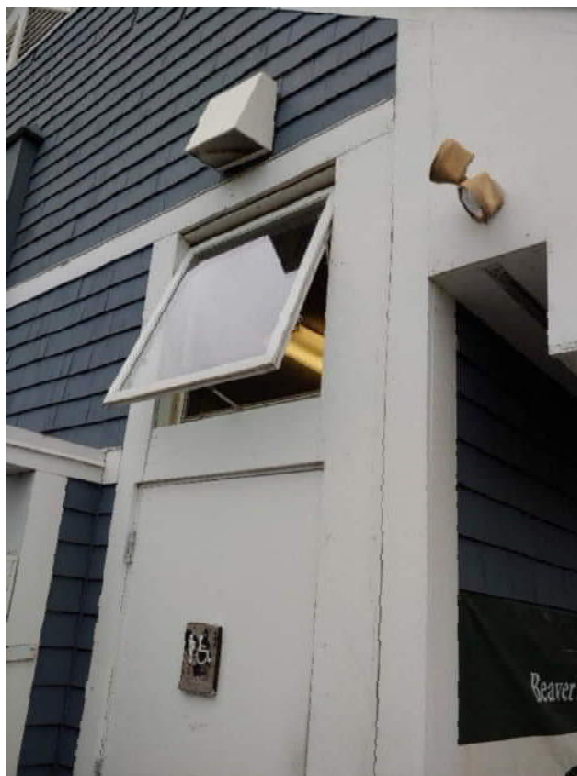
Incorrect Signs on Inaccessible Restroom Entrance

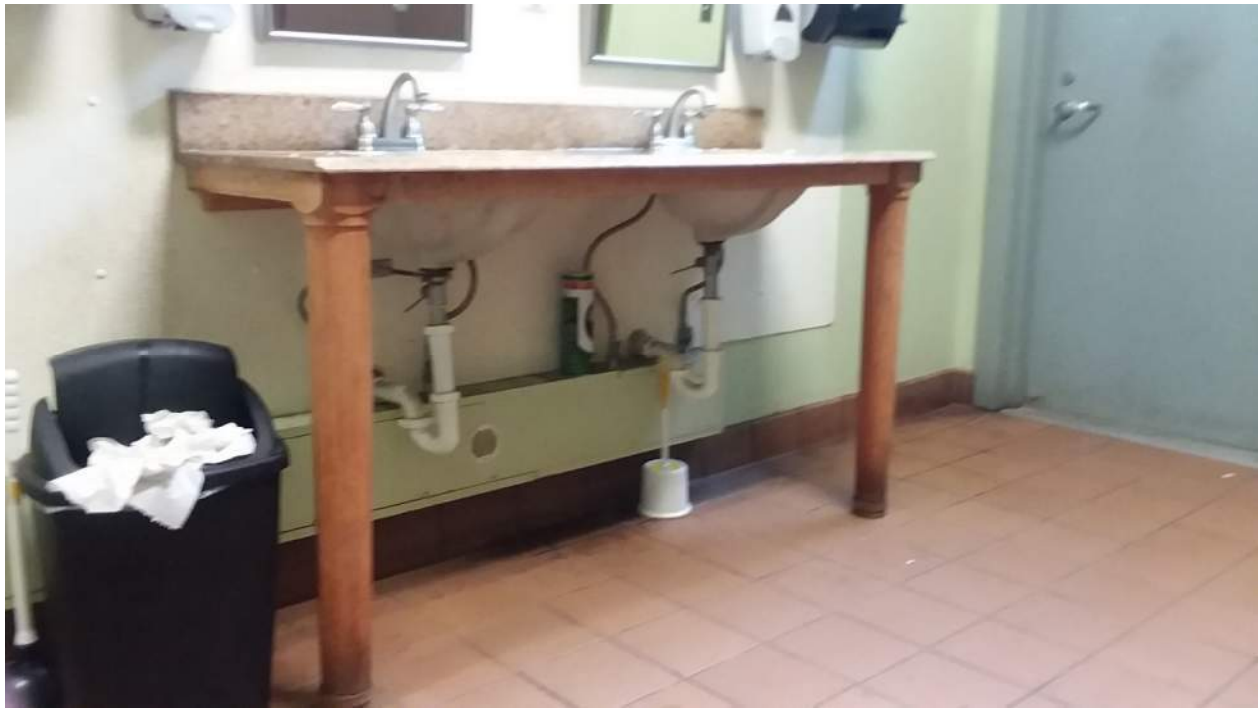
Plumbing Pipes Unprotected from Contact by Persons in Wheelchairs

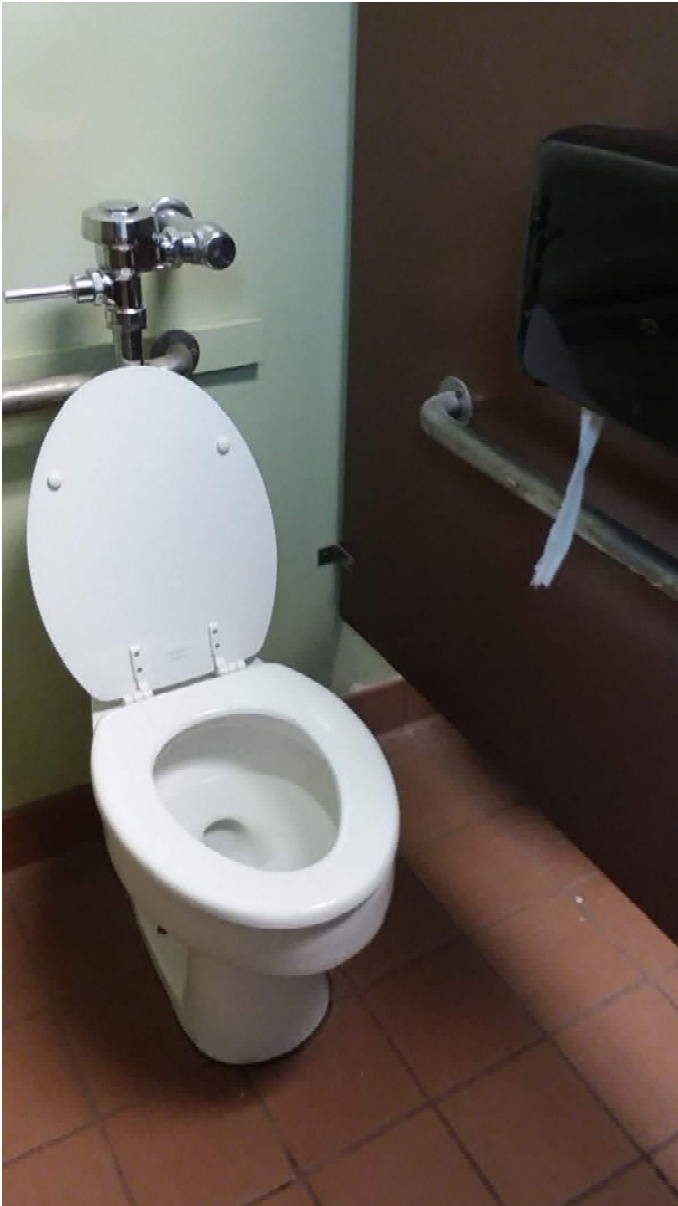
One end of the rear wall grab bars in the accessible toilet stalls in the restrooms are improperly installed and impaired by the toilet flush valve. There is not a vertical grab bar in the accessible toilet stalls.

Missing Vertical Grab Bar & Non-compliant Rear Grab Bar Impairments

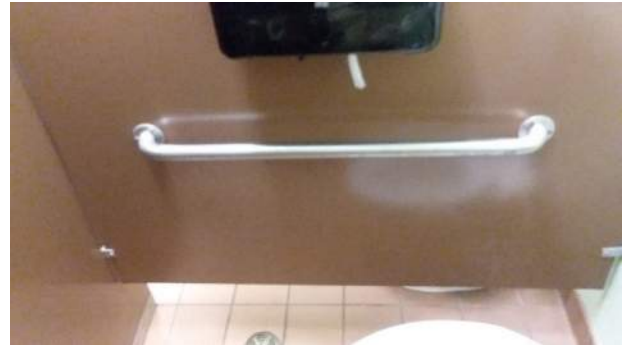
Missing Vertical Grab Bar

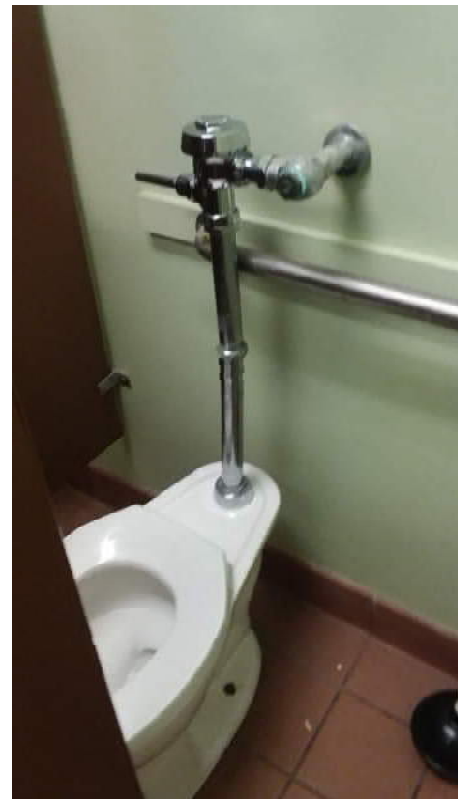
Non-compliant Rear Grab Bar Impairments
