CITY OF CONCORD, NEW HAMPSHIRE FACILITY CONDITIONS ASSESSMENT

BEAVER MEADOW GOLF COURSE CLUB HOUSE

NOVEMBER 5, 2021

TTG PROJECT No. 4980

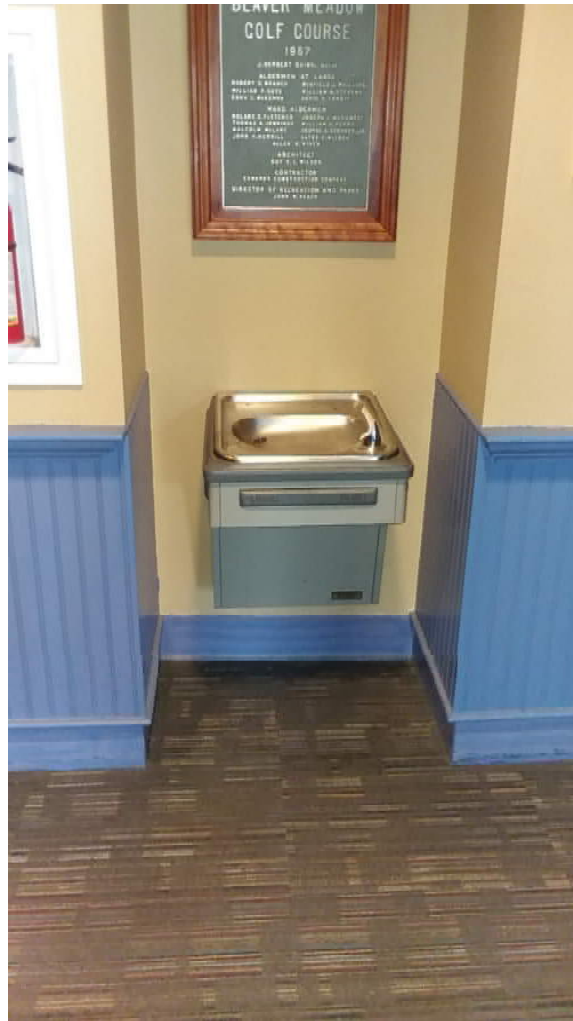
Single Drinking Fountain – Required to be High-Low Model
