CITY OF CONCORD, NEW HAMPSHIRE FACILITY CONDITIONS ASSESSMENT

BEAVER MEADOW GOLF COURSE CLUB HOUSE

NOVEMBER 5, 2021

TTG PROJECT No. 4980

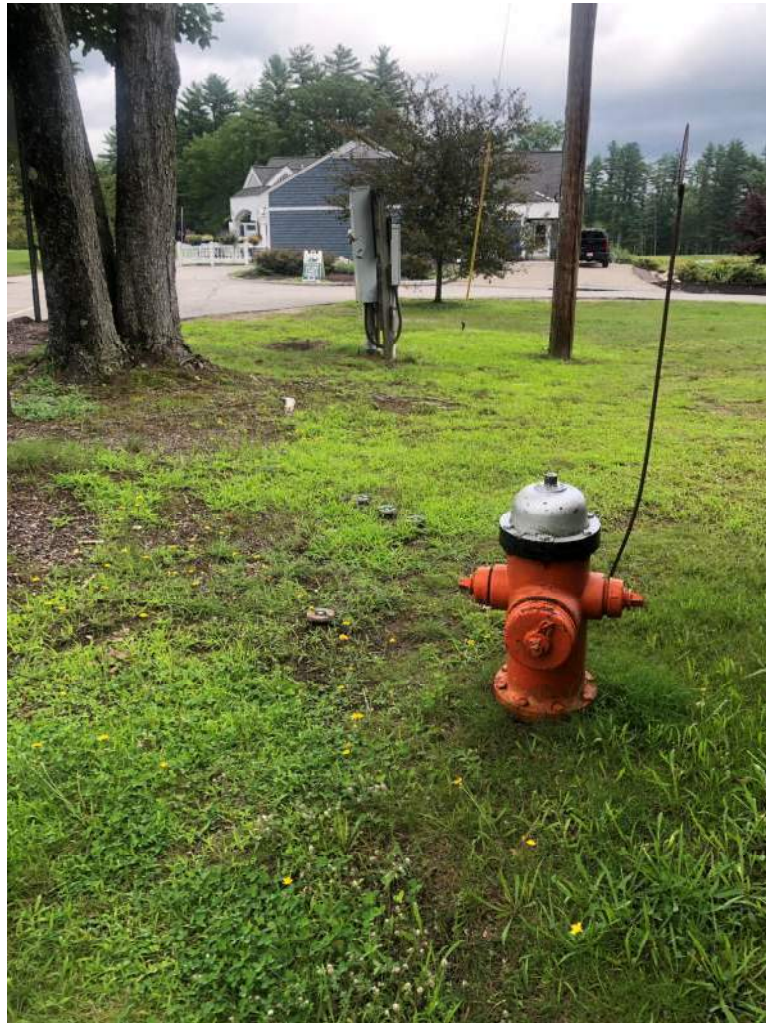
Water Hydrant and Electrical Service Located Southwest of Club House

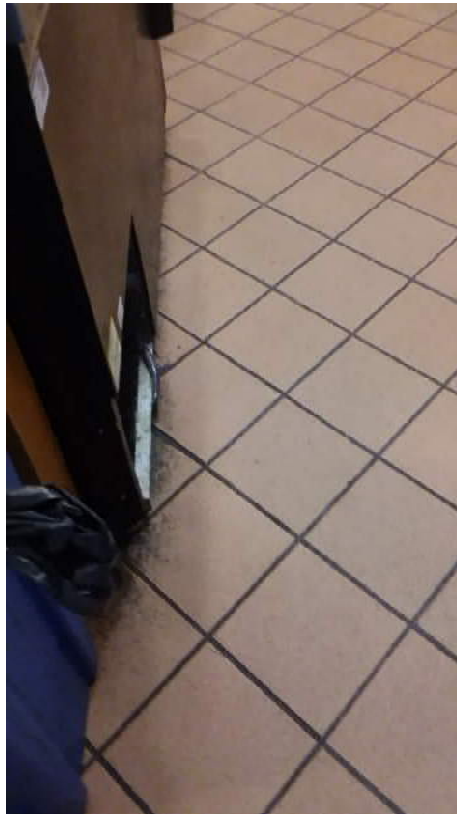
Tile Flooring Behind Public Bar

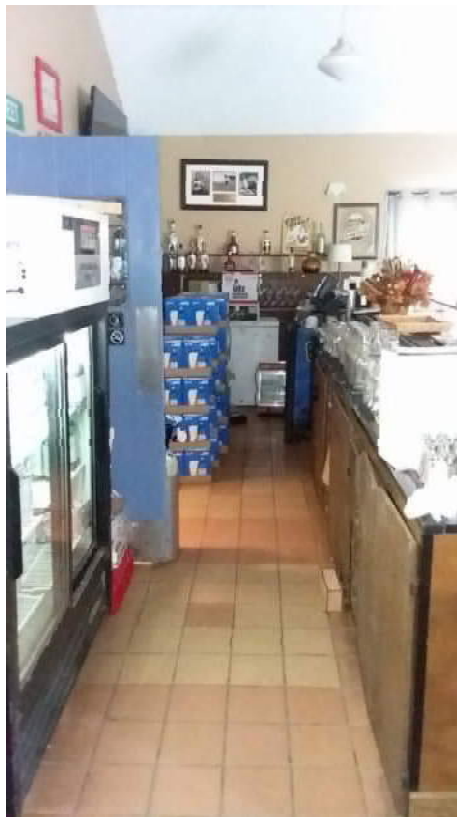
Tile Flooring Behind Clubhouse Bar

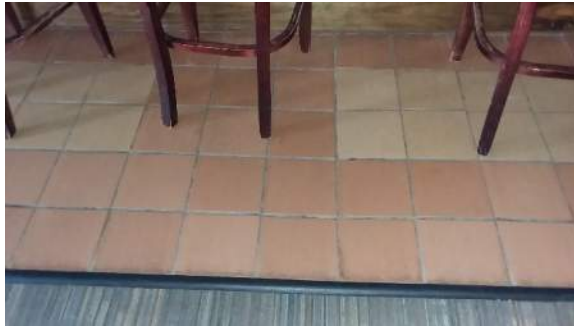
Tile Flooring in Front of Clubhouse Bar

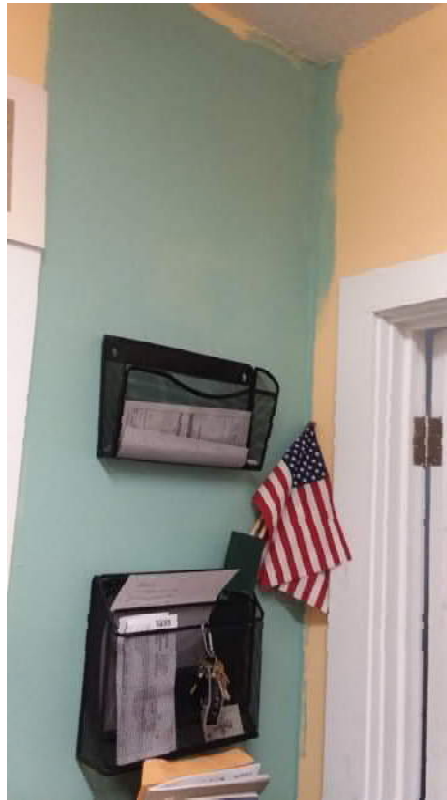
Wall Finish in Private Office

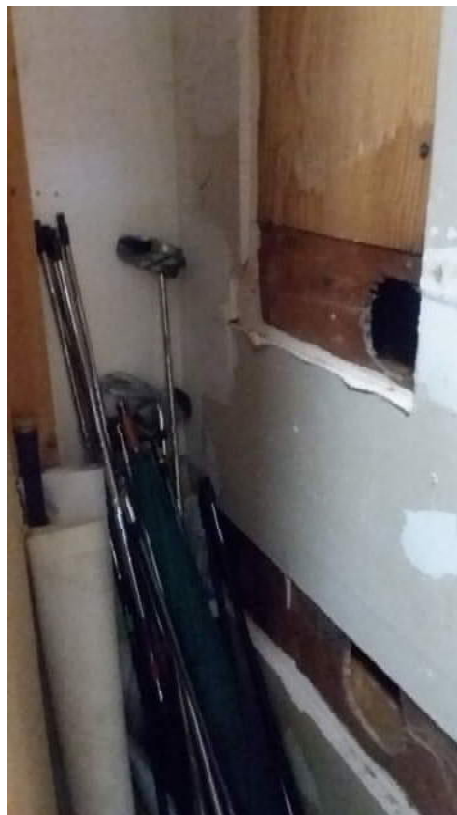
Wall Finish in Office Closet

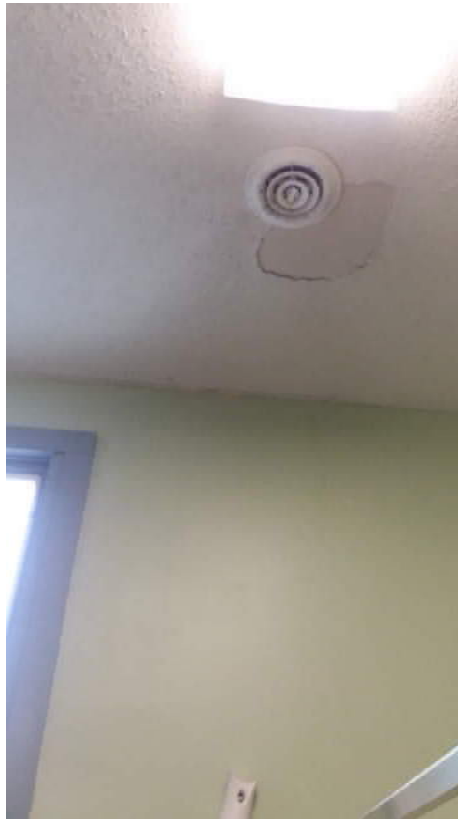
Ceiling Finish in Men's Restroom

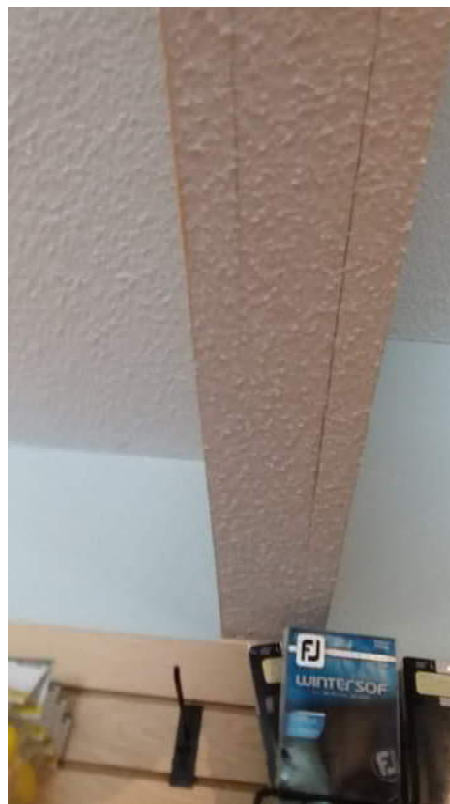
Beam Cladding Finish in Pro Shop

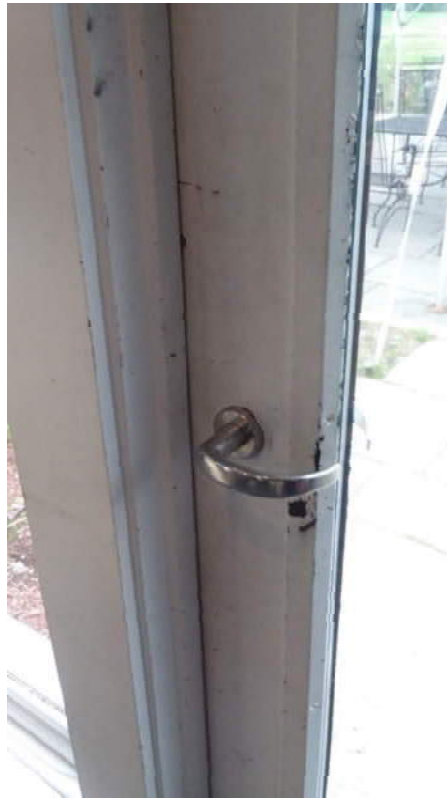
Interior of Exterior Door in Pro Shop

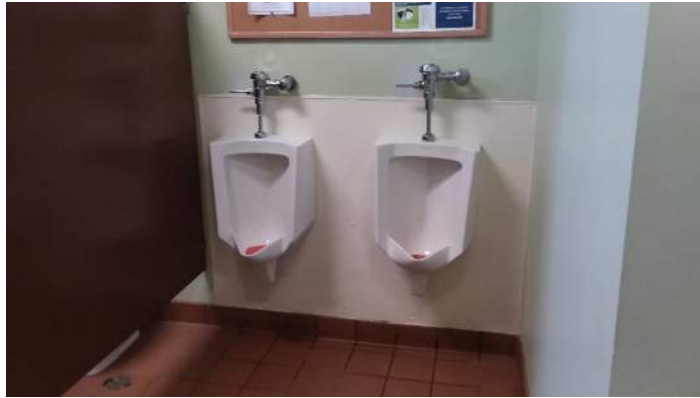
Compliant Smooth, Hard, Nonabsorbent Wall Surfaces Required within Two-Feet of Toilets & Urinals

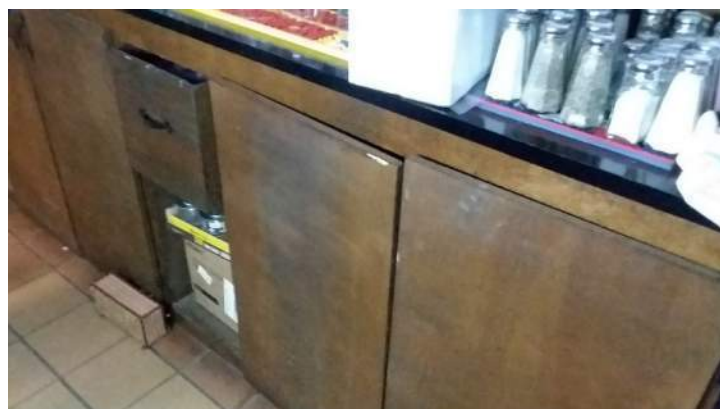
Condition of Finishes on Casework Behind Clubhouse Bar

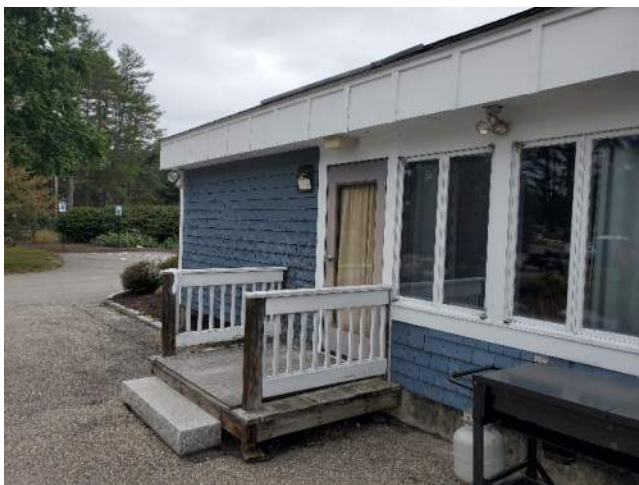
Non-Accessible Sign and Directional Sign to Accessible Entrance Required

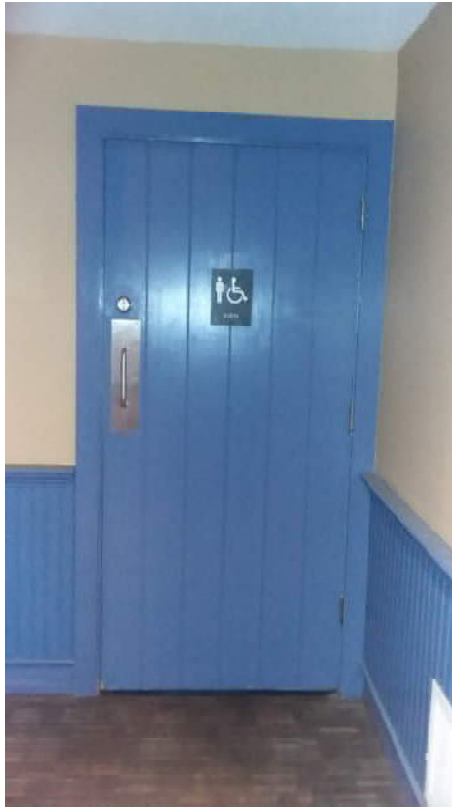
Accessible Restroom Signage Required on Wall Adjacent to Pull Side of Doors – Not Mounted on Doors

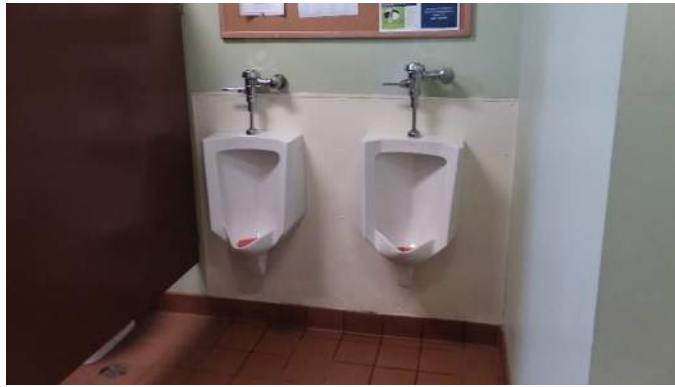
One Urinal Required to be Accessible when More Than One is Provided

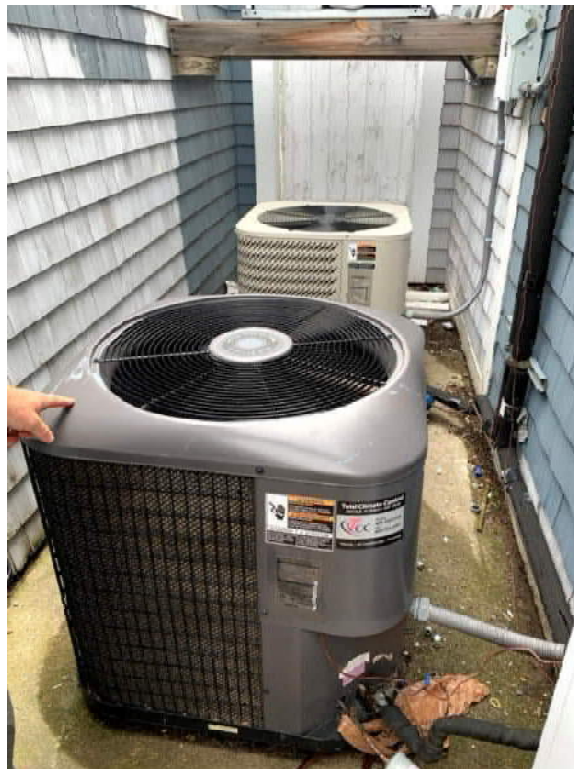
Air conditioning condensing units

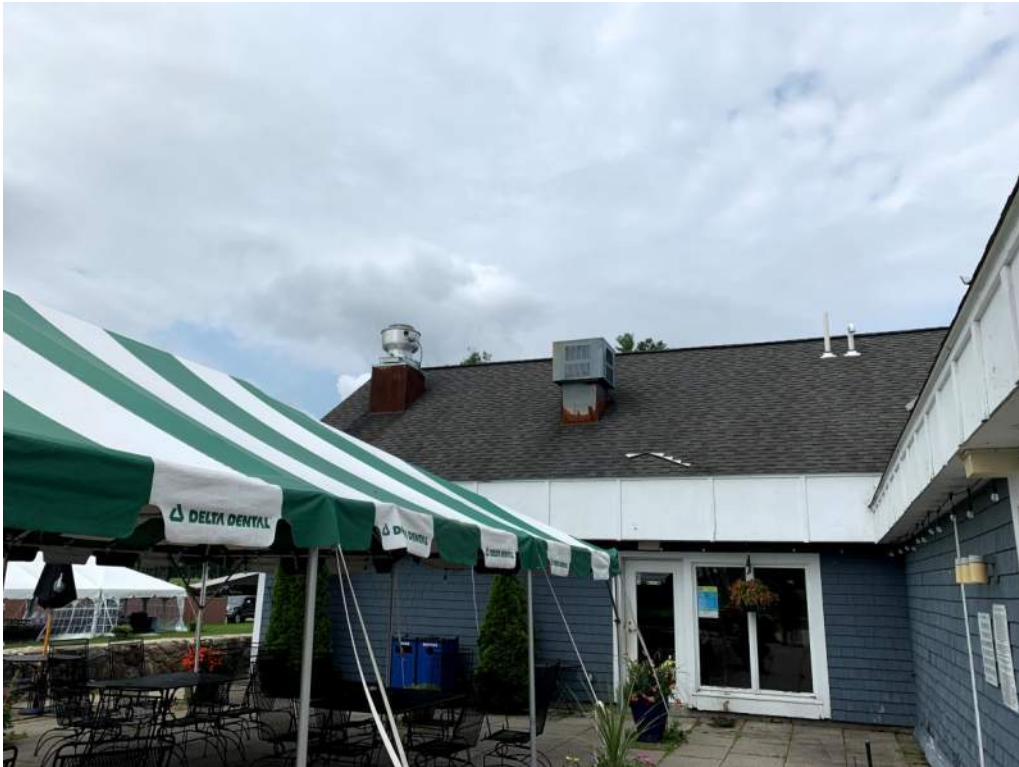
Intake and exhaust fan for kitchen hood

We recommend replacement of the bathroom furnace unit, along with improved access. Outside air should be introduced to the remaining two heat/air conditioning units. We also recommend that the bathroom exhaust fan be repaired or replaced. If work is done that affects the kitchen hood exhaust system, we recommend adding a vented extension to the roof curb.

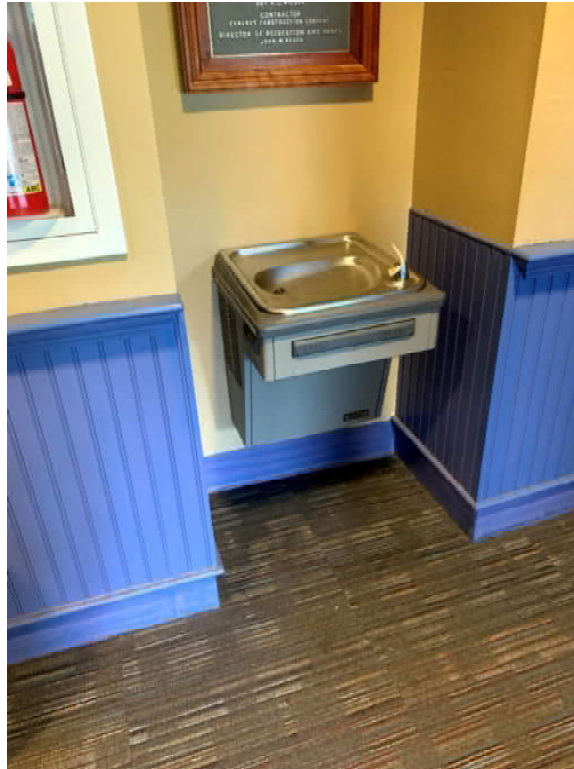
A water fountain is located near the front of the building outside the bathrooms and appears in good condition.

Water fountain

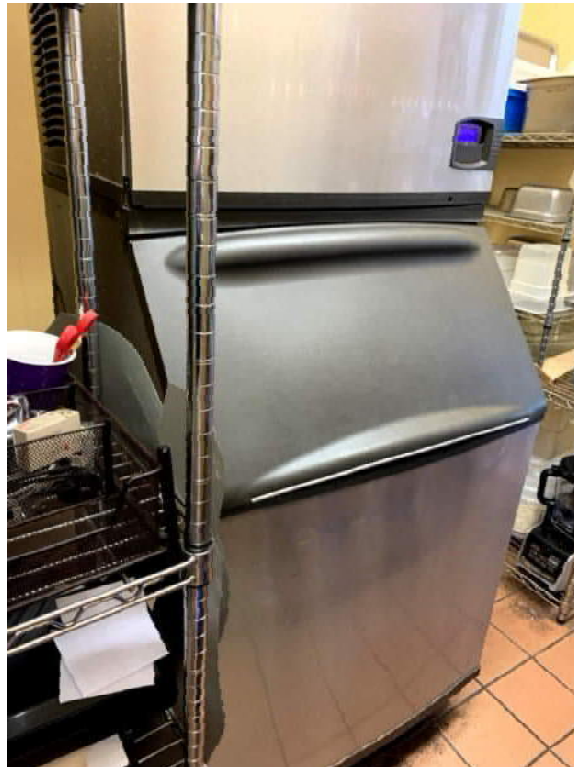
The kitchen area has an underfloor grease trap that is downstream of the kitchen floor drain and the prep sink. The kitchen also has an ice maker that appears in good condition.

Ice Maker
